EMPIT

Electromagnetic Pipeline Testing GmbH

01 // Technique

02 // Inspection

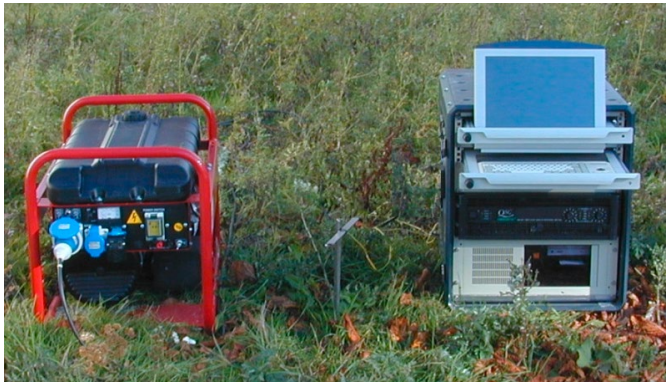
Power Generator (left) and Current Source (right)

All unpiggable pipelines are inspected through aboveground inspection (AGI). This is done by analyzing the A. C. magnetic field of the pipeline aboveground. This magnetic field is induced by an inspection current that is introduced into the pipeline. In order to generate the inspection current, we have developed a special current source – shown in the picture below.

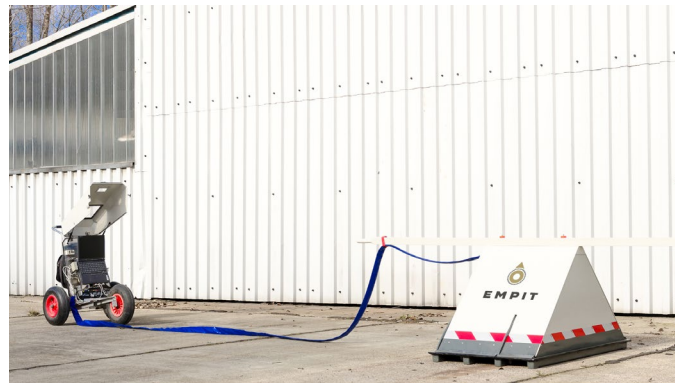
Data Collector Module (left) and Sensor Array (right)

Another essential part of our technique is the inspection system. The Sensor Array (SA), seen on the right side of the picture, holds 24 sensors. Each of them measures the horizontal component of the magnetic field. The data is transferred to the Data Collector Module (DCM), which shows direct information of the pipeline on the screen. Data of the magnetic field, the level of the inspection current, the pipeline depth, and the coordinates of the Sensor Array over the pipeline will be stored.

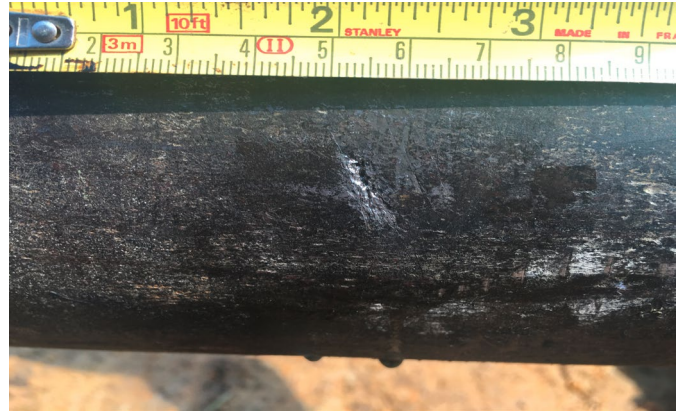
Example of Defect "Detection below Level 1"

Detection below Level 1 - is used when a metal loss feature is in at least one coordinate smaller than the reference defect in this level. Detection of features starts if the metal loss is greater than 20 %.

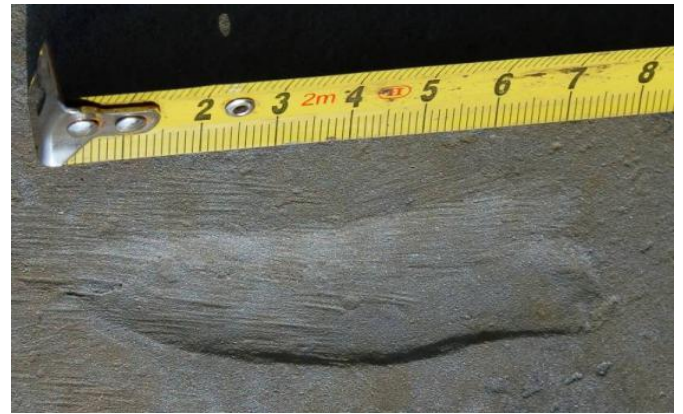
Example of Defect "Detection below Level 2"

Detection below Level 2 - is used when a metal loss feature is in at least one coordinate smaller than the reference defect in this level.

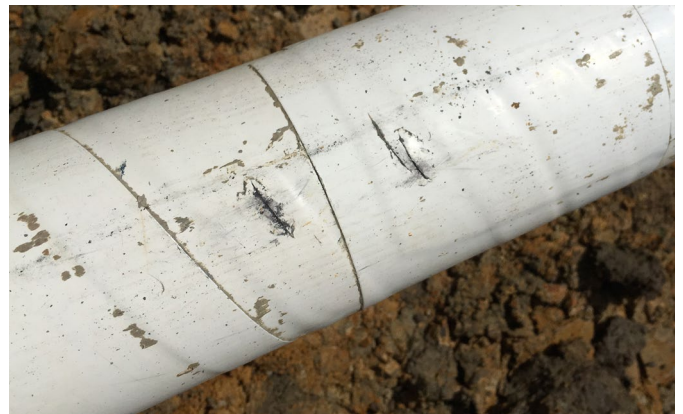
Example of Coating Feature

In addition to the faults survey, the intensity of the inspection current is monitored. At places, where the insulation (coating) of the pipeline is characterized by a defect, a small part of the inspection current leaks into the surrounding earth. As a result, the inspection current changes, which can be recognized from current plots.

The calculated inspection current values are plotted and presented in the graphic analysis, which is done for every inspected pipeline. A normalized scaling is used in current plots. As reference values for the normalization of the current, values at the current source output are used. Normally, the current value is changing monotonously along the pipeline due to the slight leakage of the pipeline coating. But in places where the coating is damaged the leakage is stronger and this produces a jump on the current plot, recognized by our system. Using this feature, coating damages will be detected. The threshold level for current leakage depends on coating kind, OD of the pipe and the soil conditions. For instance, the steepness of 0.3%/m can be used. Changes of the inspection current are indicated if the current jump feature is at least 1.5 m long.

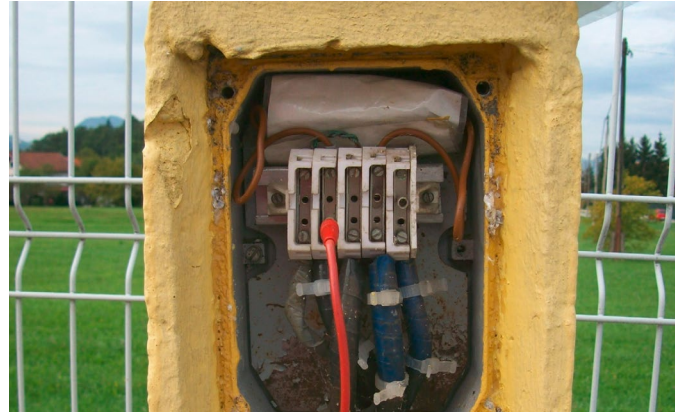
Connection through CP-Post

- The graphic below shows the schematic visualisation of the setup for the inspection run - In order to create a measurable magnetic field, surrounding the pipeline, an A.C current is introduced into the pipeline. This can be either done through parts of the pipeline running above the ground (e.g. valves), through Cathodic-Protection-posts, or through dug holes. The two connection points should not lie more than 1,000 meters apart. After contacting and laying out the connection cable, a quick functional test is carried out. Then, the actual inspection begins. Starting point is one of the two connection points.

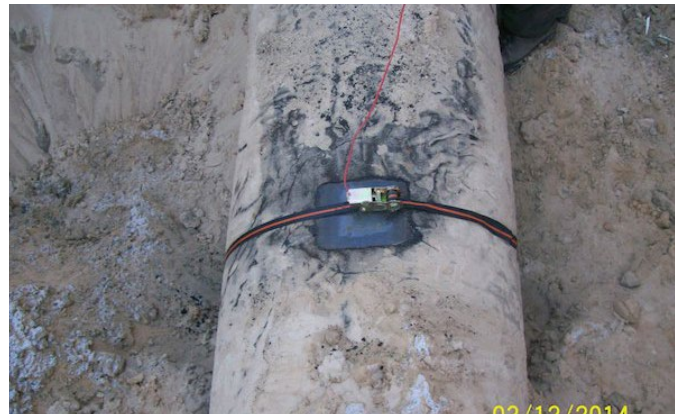
Connection through dug hole

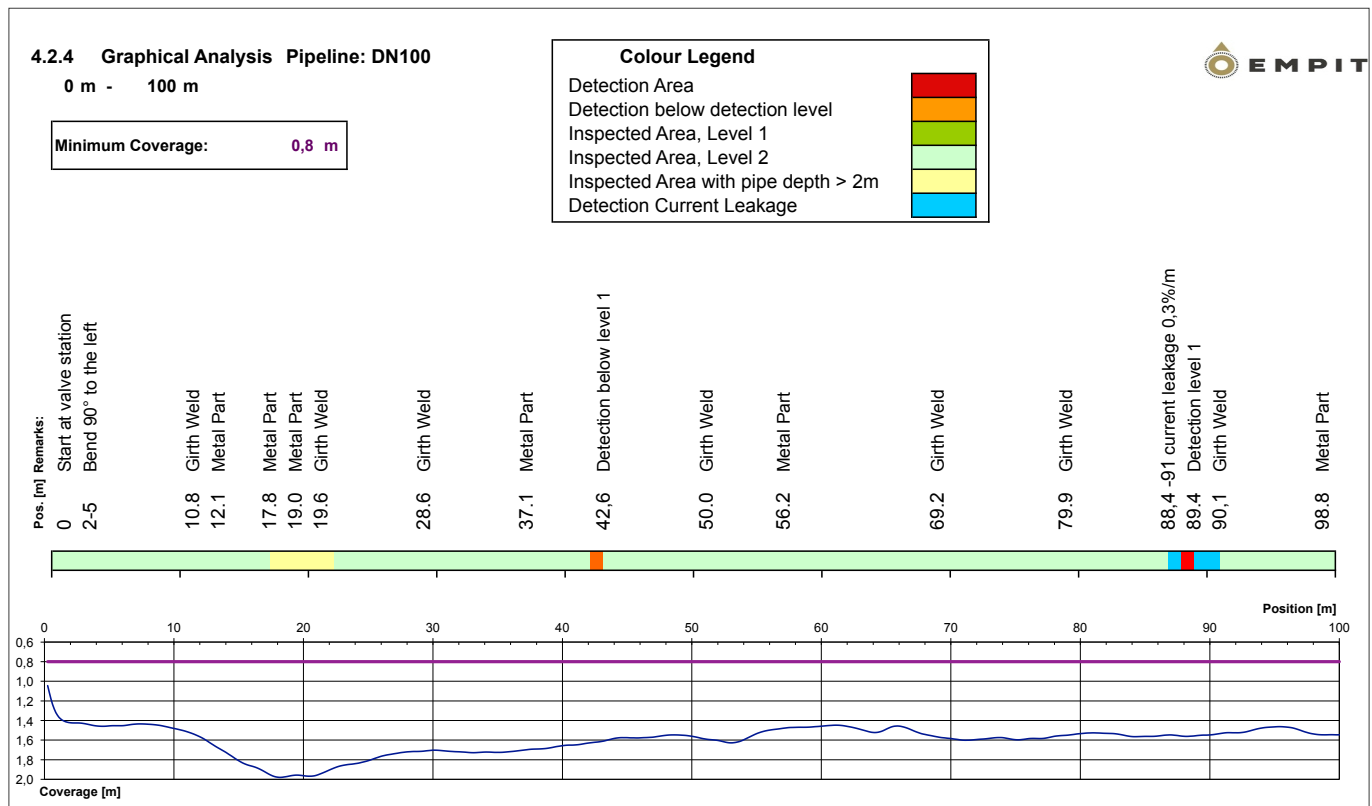
Results 0 m – 100m: (see graphic below)

| (1) 42,6 m | Metal loss feature, “below Level 1” |
| (2) 89,4 m | Metal loss feature, “Level 1” |
| (3) 88,4 m – 91 m | Coating defect, 0,3 % / m |

The graphical analysis is based on magnetic field variation parameters. The bar, which is seen in the spreadsheet, schematically visualizes 100 m of the inspected pipeline. The bar is characterized by different colors – each has a different indication:

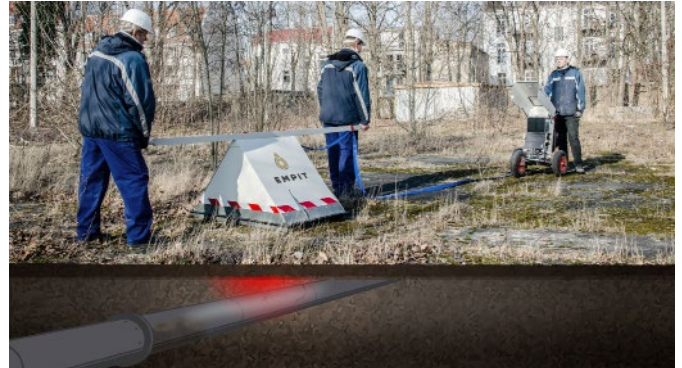
EMPIT-Crew during inspection

The inspection technique finds the exact coordinates of the pipeline. While a usual pipe-finder holds 2 sensors, our system holds 24 sensors, which makes it to the best pipe-finder in the world. Consequently, it is possible for the pipeline operator to get exact information of the position of the pipeline.

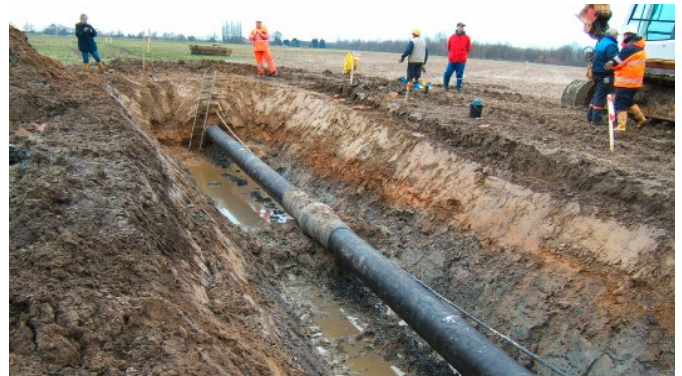
Excavation of metal loss defect and coating defect
